911 GT1

#017

Pre Purchase Inspection

VIN: WP0ZZZ99ZWS396017

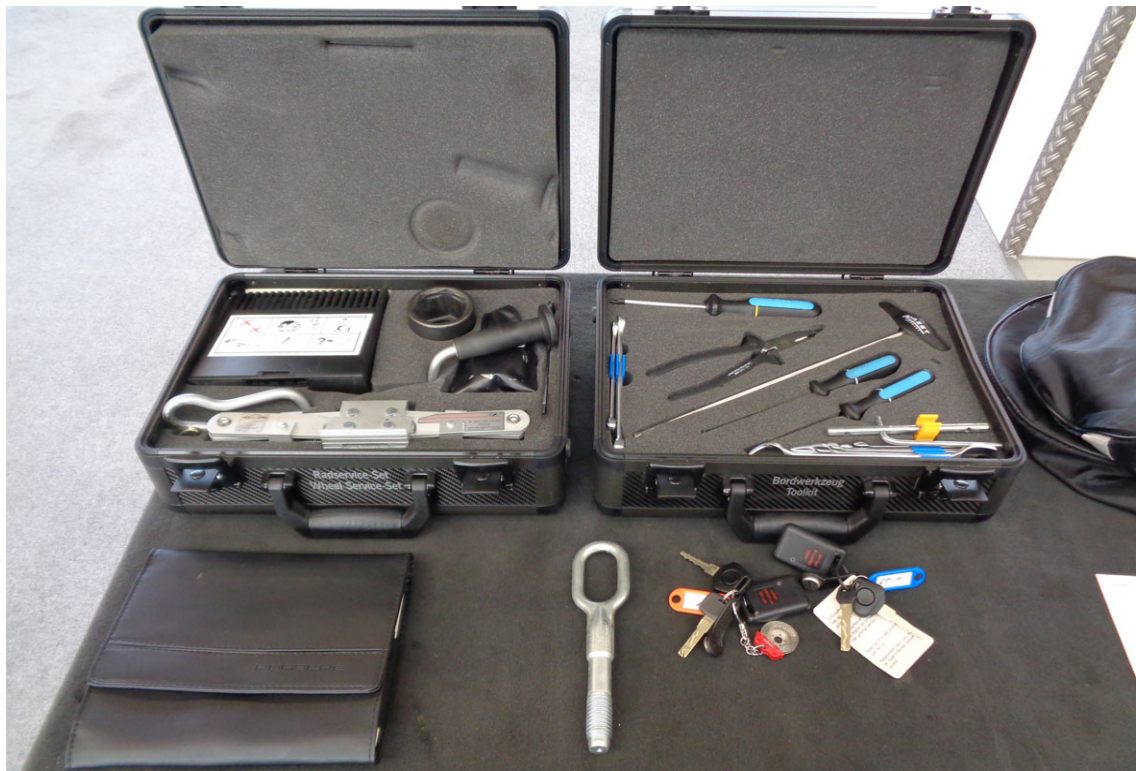
The car presents very well and has obviously been well looked after.

Especially the preservation of the mechanical components is worthy to be mentioned, the vehicle must always have been stored in a suitable environment as there is hardly any surface rust or oxidation on elements that have no protective coatings on them.

Both of the rare carbon fibre GT1 toolboxes, all keys, owners manual and service book are present. Also the factory car cover is there.

The only item missing is the extra thicker lower seat cushions.

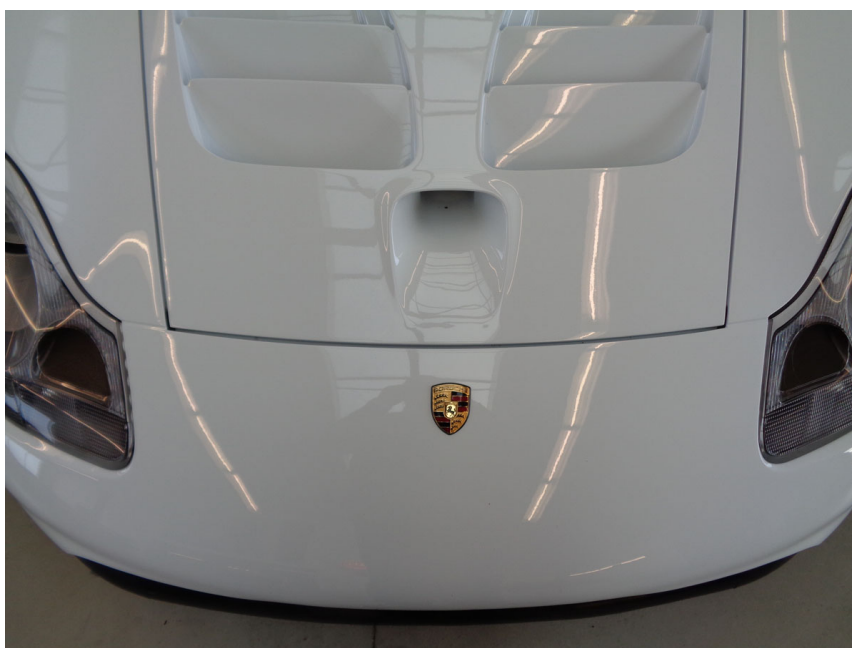
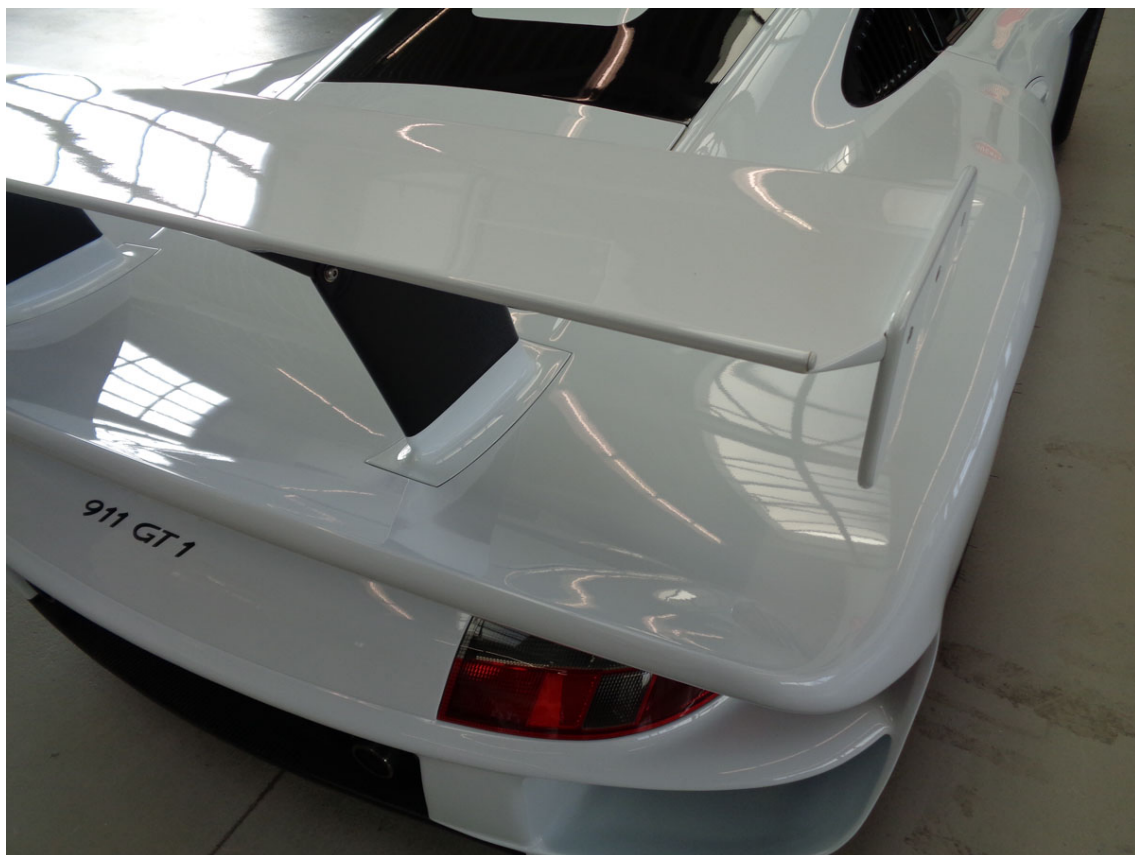
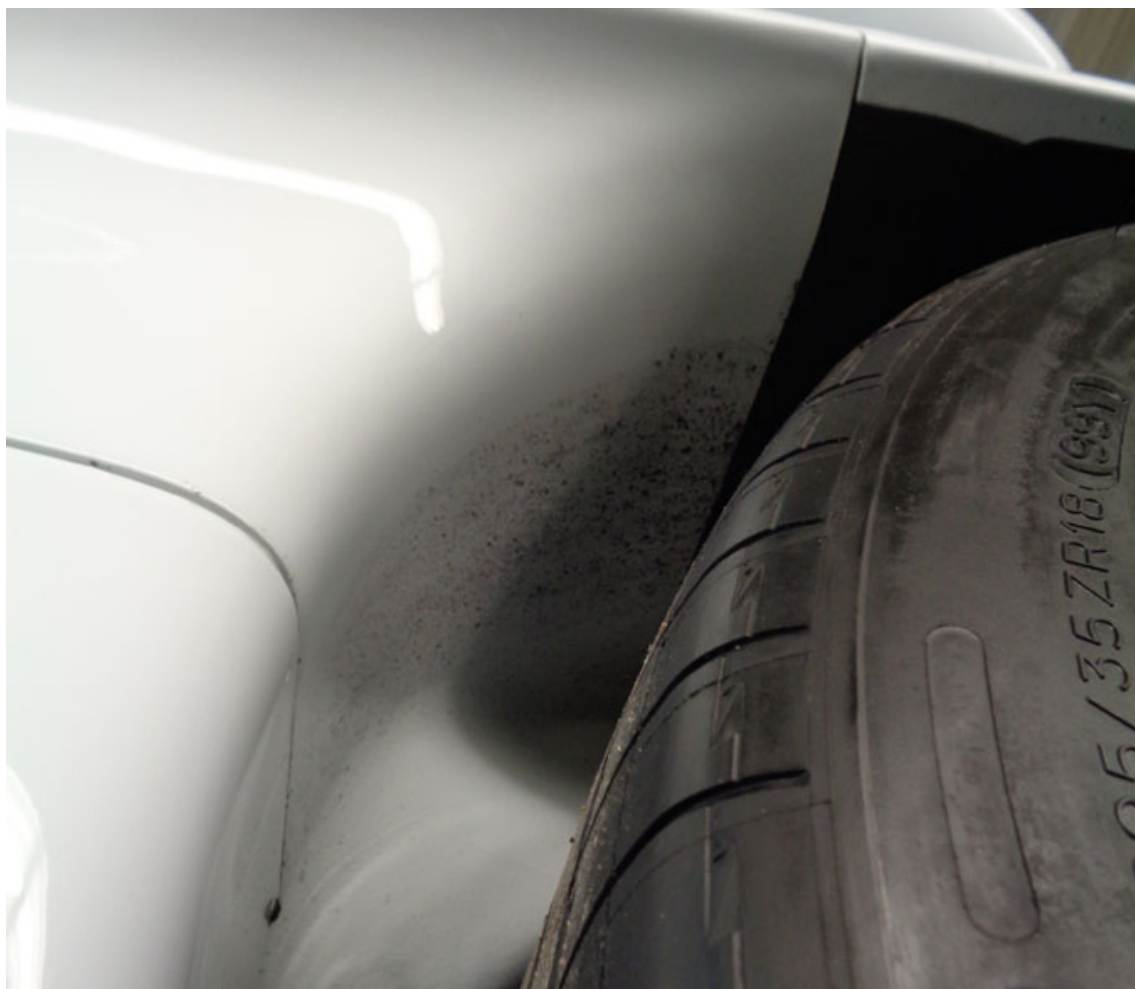
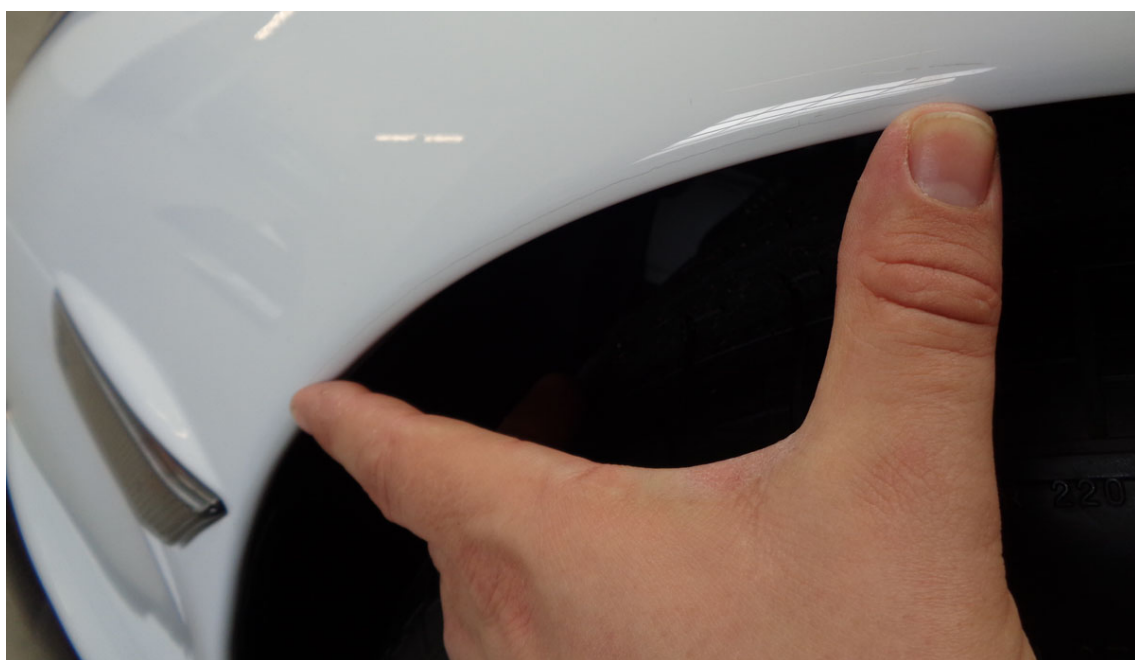
BODY:

Normal stone chips are to be found all over the car's nose and inner fenders, however the rear engine lid seems to have been repainted. It was also noted that the outer rocker panels have been previously removed and repainted.

The carbon fibre structure can be clearly seen through the paint in the reflections on the roof, doors, rear trunk lid, fake rear window, door window frames and most of the nose. These elements are in my opinion all in original paint. Also the ultrasound readings confirmed this. The other panels (tail section and both rocker cover panels) showed thicker paint and not the same finish, orange peel and some dust in the paint.

There is no evidence to be found anywhere that this car would of have ever been crashed. It seems that all bodywork has been carried out purely for aesthetic reasons, to cover up stone chips.

Some scratches on the edges of the doors, some minor cracks in some of the outer body panels. The unpainted carbon fibre parts on the edges of the bumpers and on the tail show some scratches here and there.

The thick protective transparent plastic that is normally found on the edges of the fenders has been removed on all four fenders.

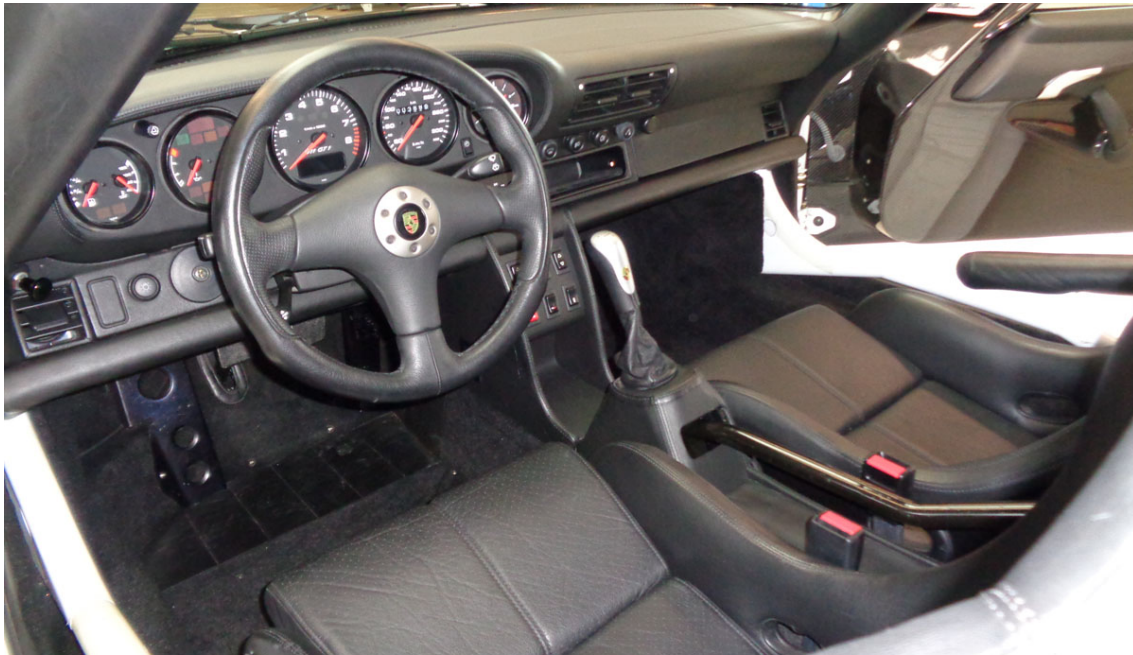
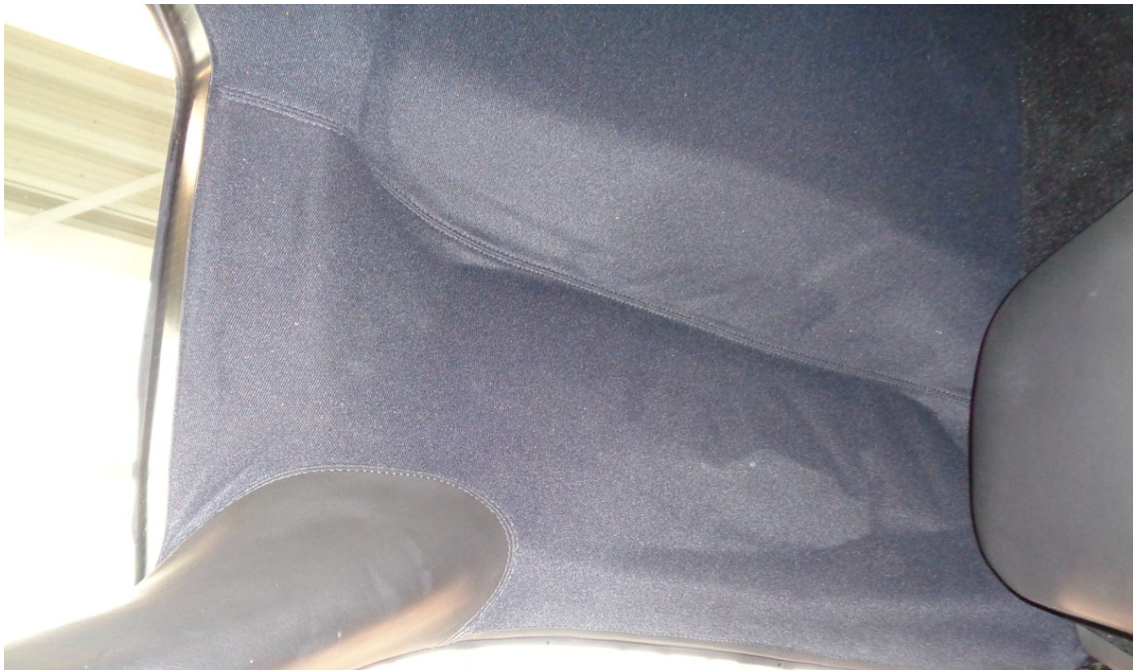
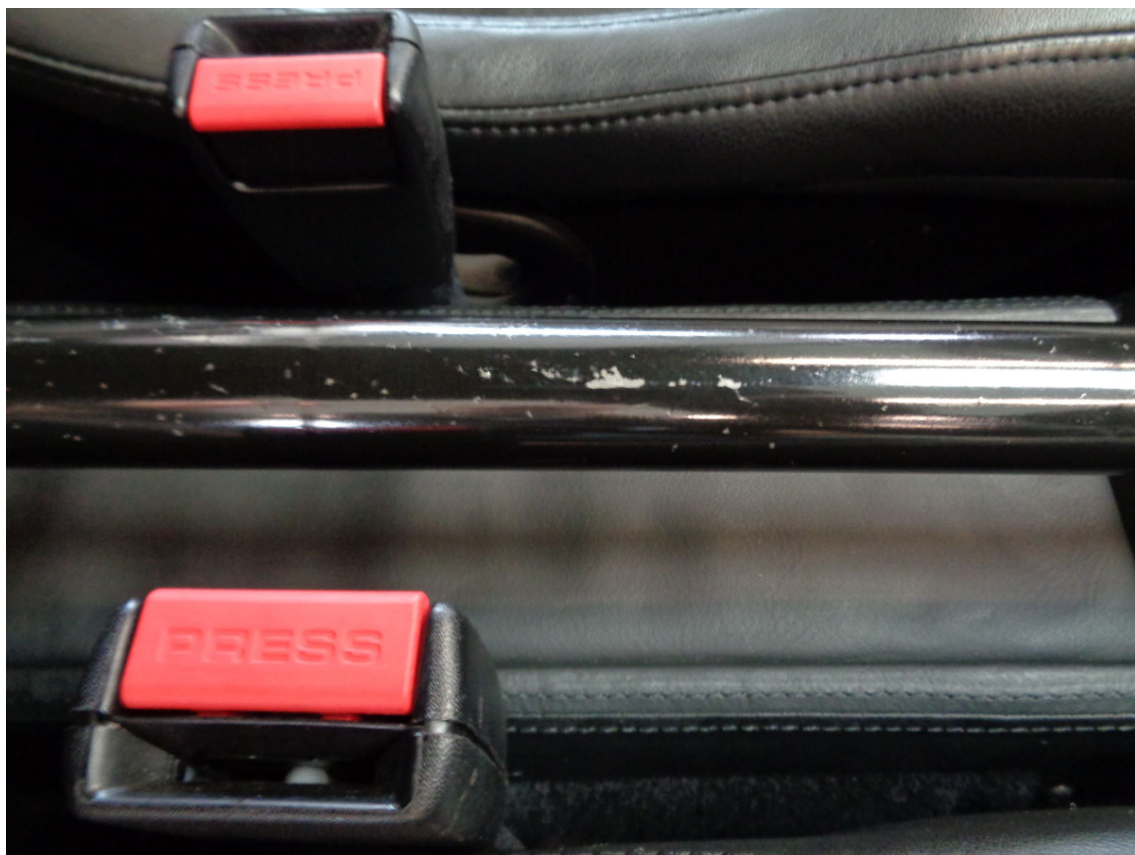
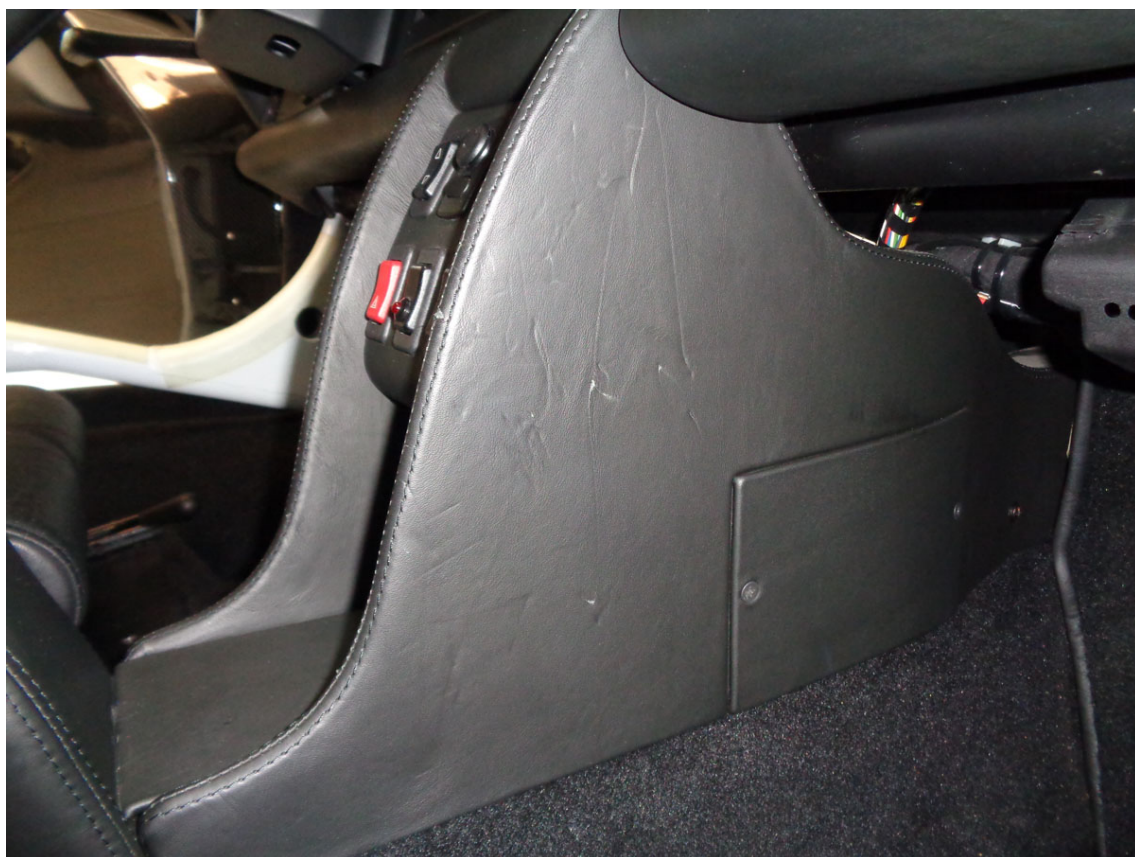
INTERIOR:

The seats are in very good condition with just some minimal imperfections. On the centre console there are quite a few scrapes in the leather from shoes hitting it and the shift rod inside the driver's compartment shows a lot of scratches and chips in the paint.

The headliner is sagging; this is a common flaw on GT1's.

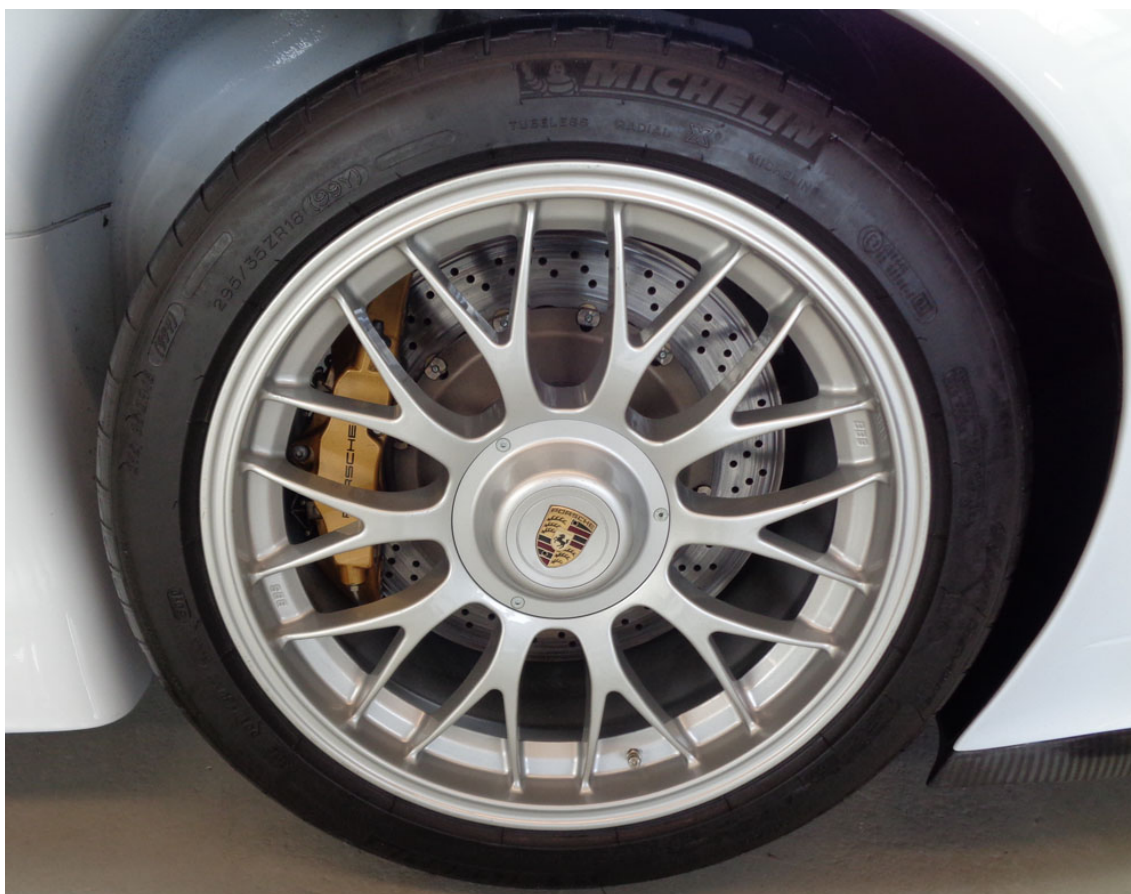
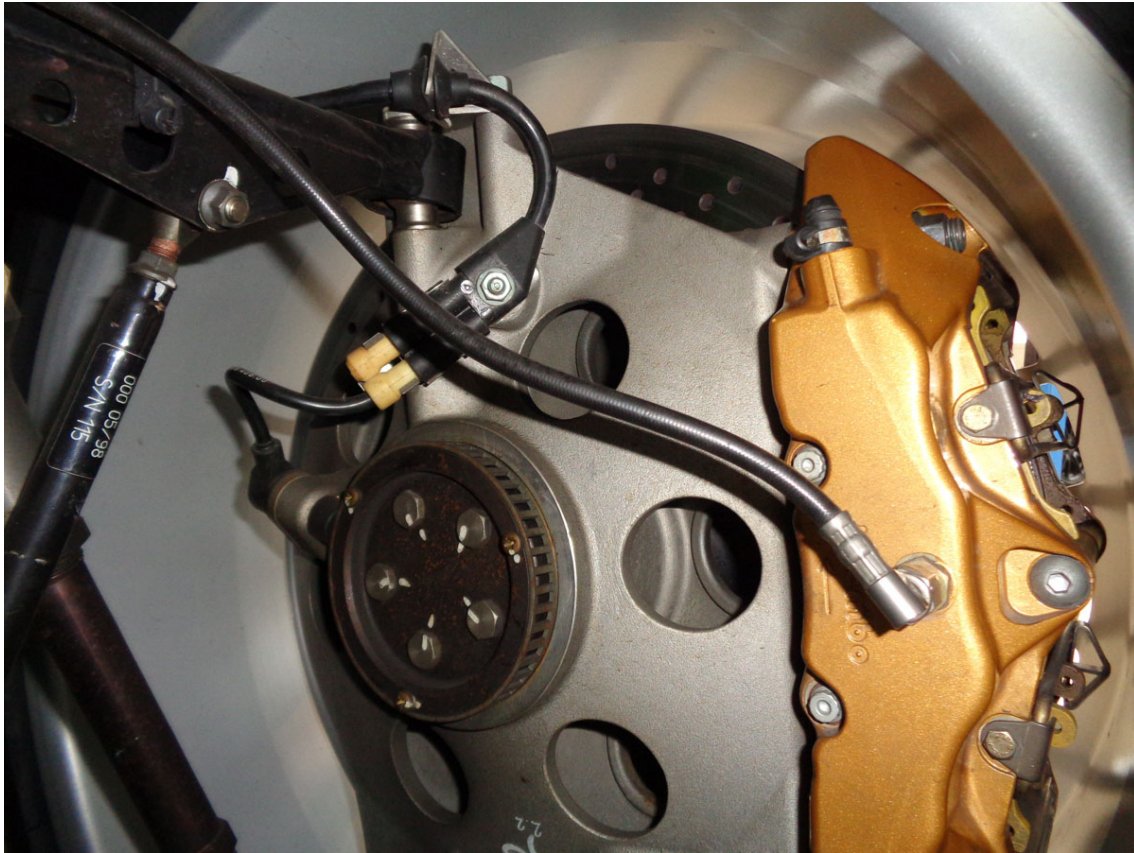
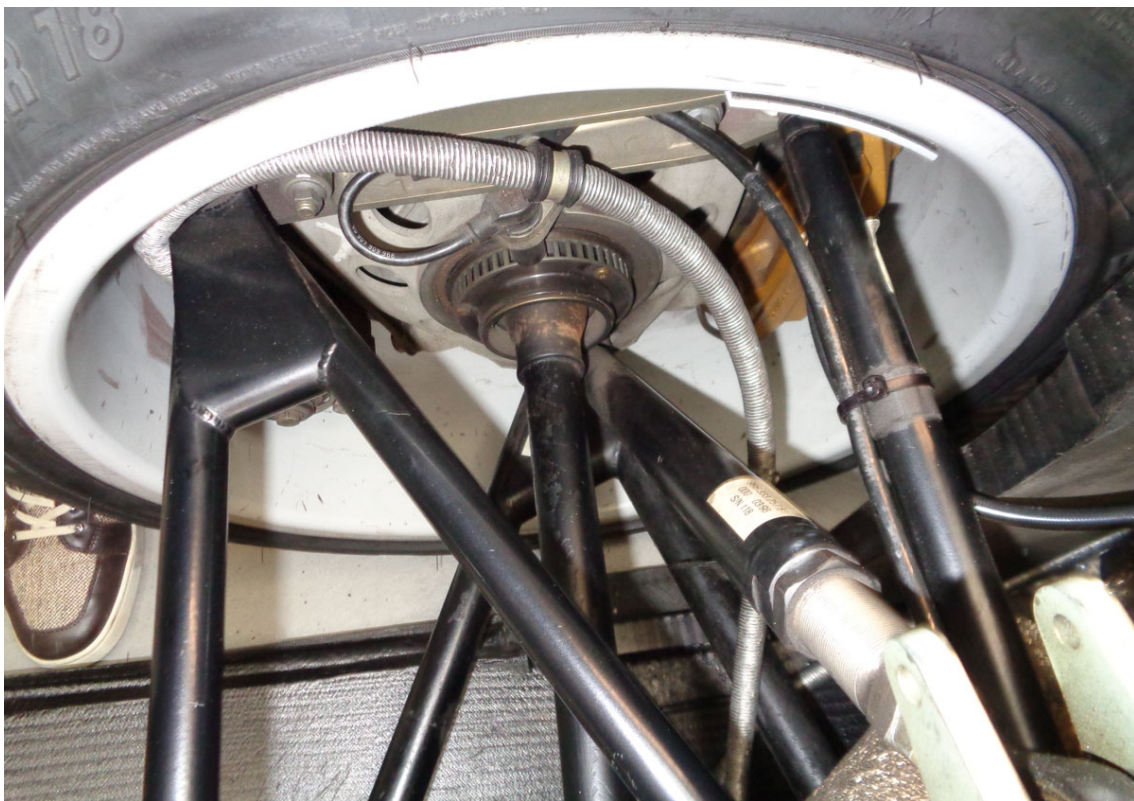
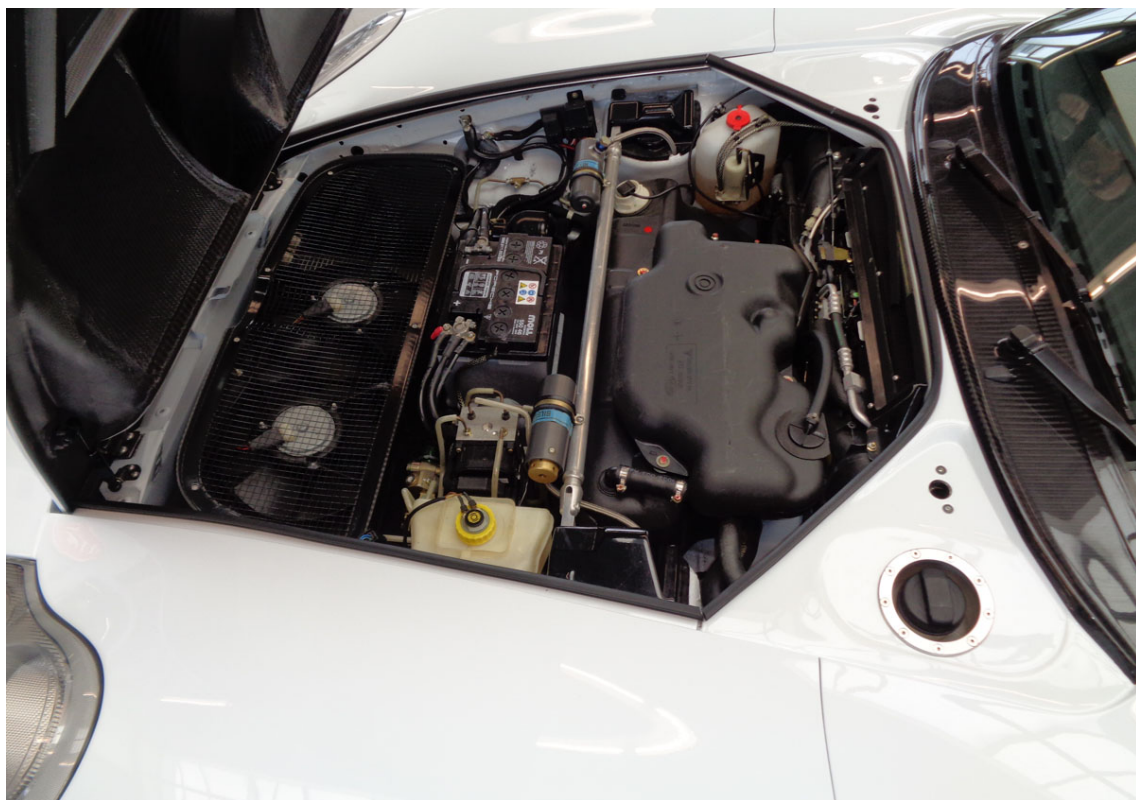
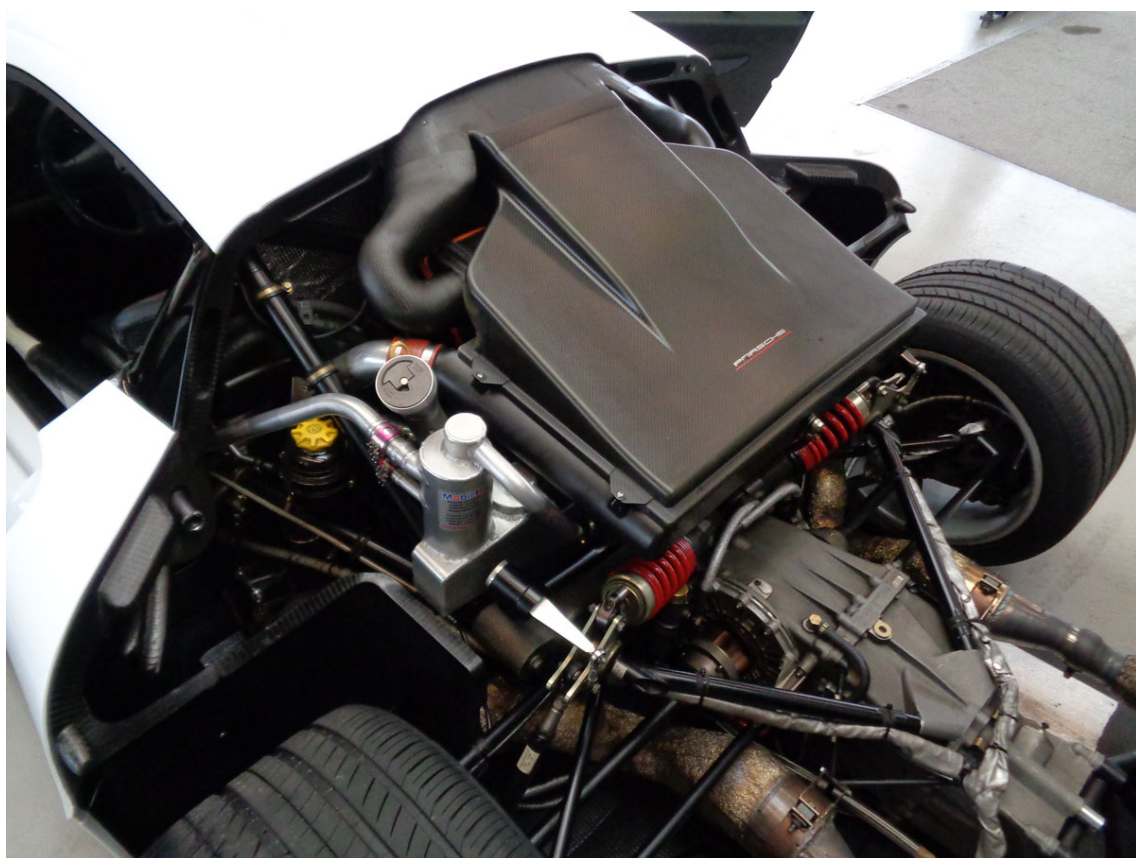
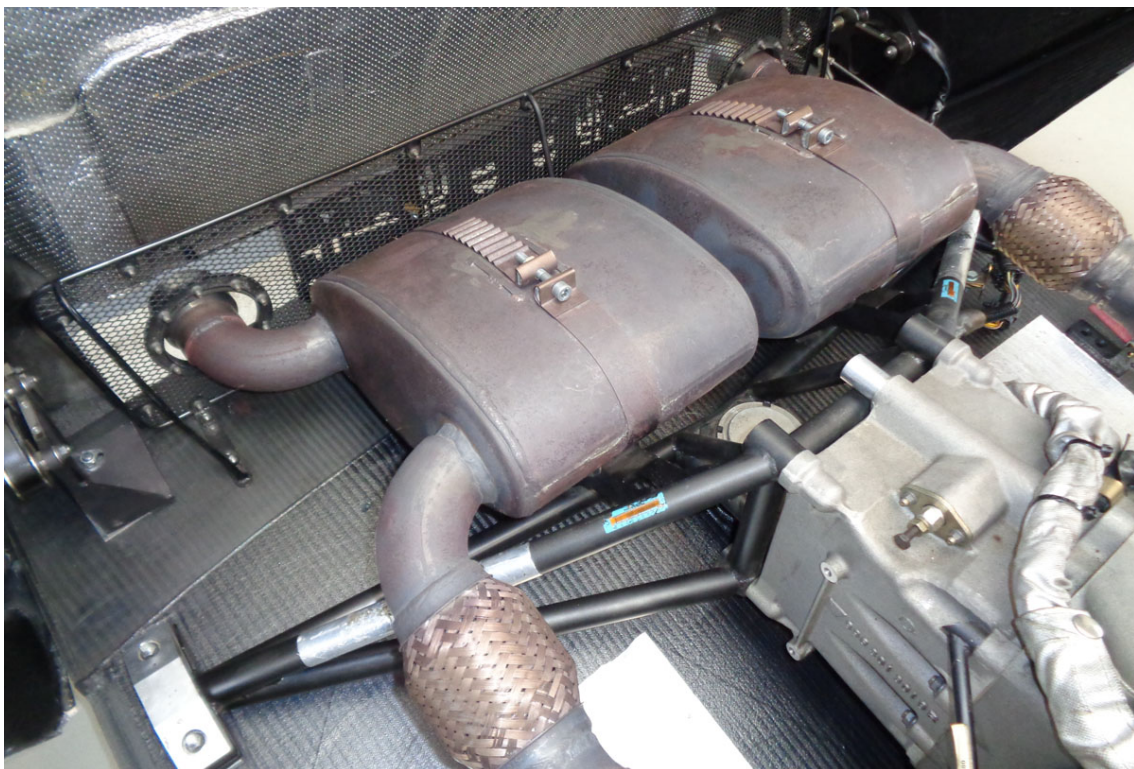
RUNNING GEAR:

The tires are dated 2010 for the front ones and 2012 for the rears.

Brake rotors show small hairline cracks, nothing abnormal for a car like this and well within tolerance (less than 5-6mm), the brake callipers show some flaked off paint and some small chips.

The wheels have slight scrape marks and some minor paint chips, however I was told the car comes with a spare set of brand new wheels. These do not have spare centre caps, not sure that those are available these days.

Only very minor surface rust of some of the suspension components.

There are some traces of a coolant leak in the past on and around the engine, nothing major, could also be due to over filling the coolant reservoir.

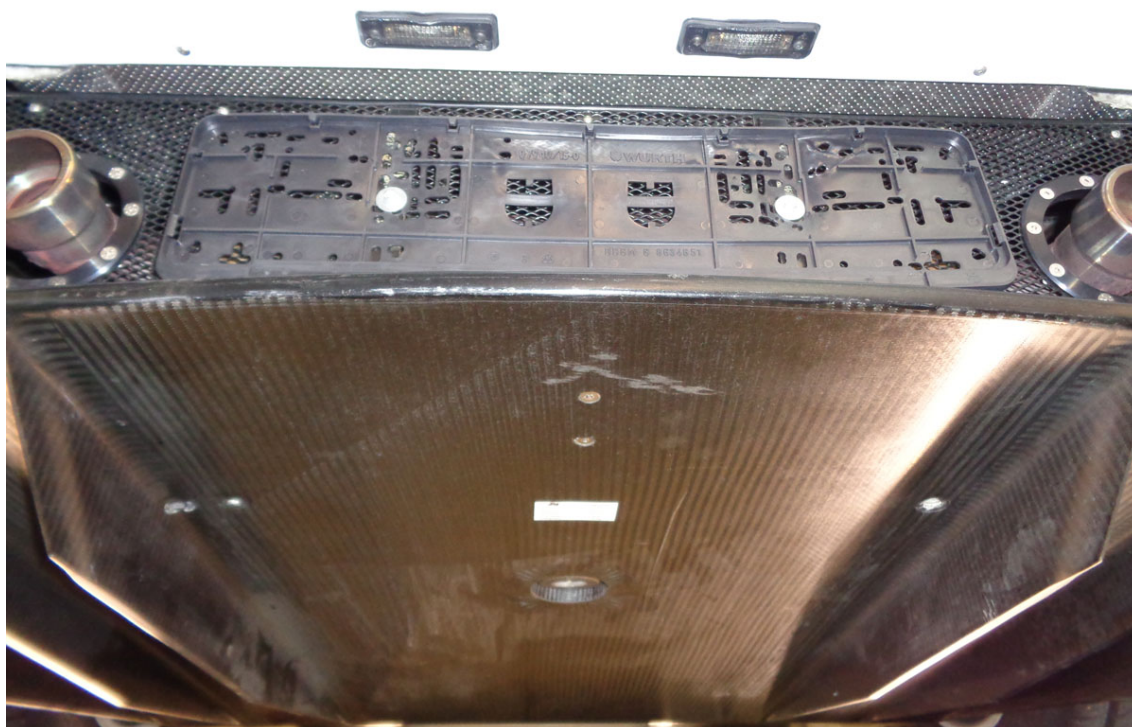
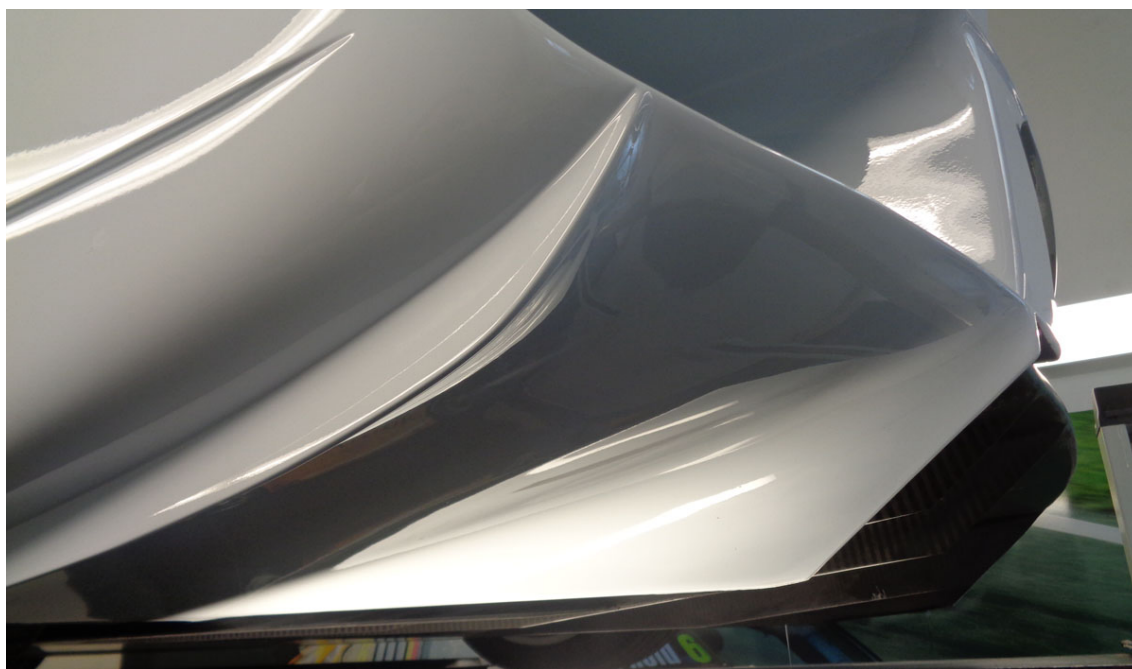
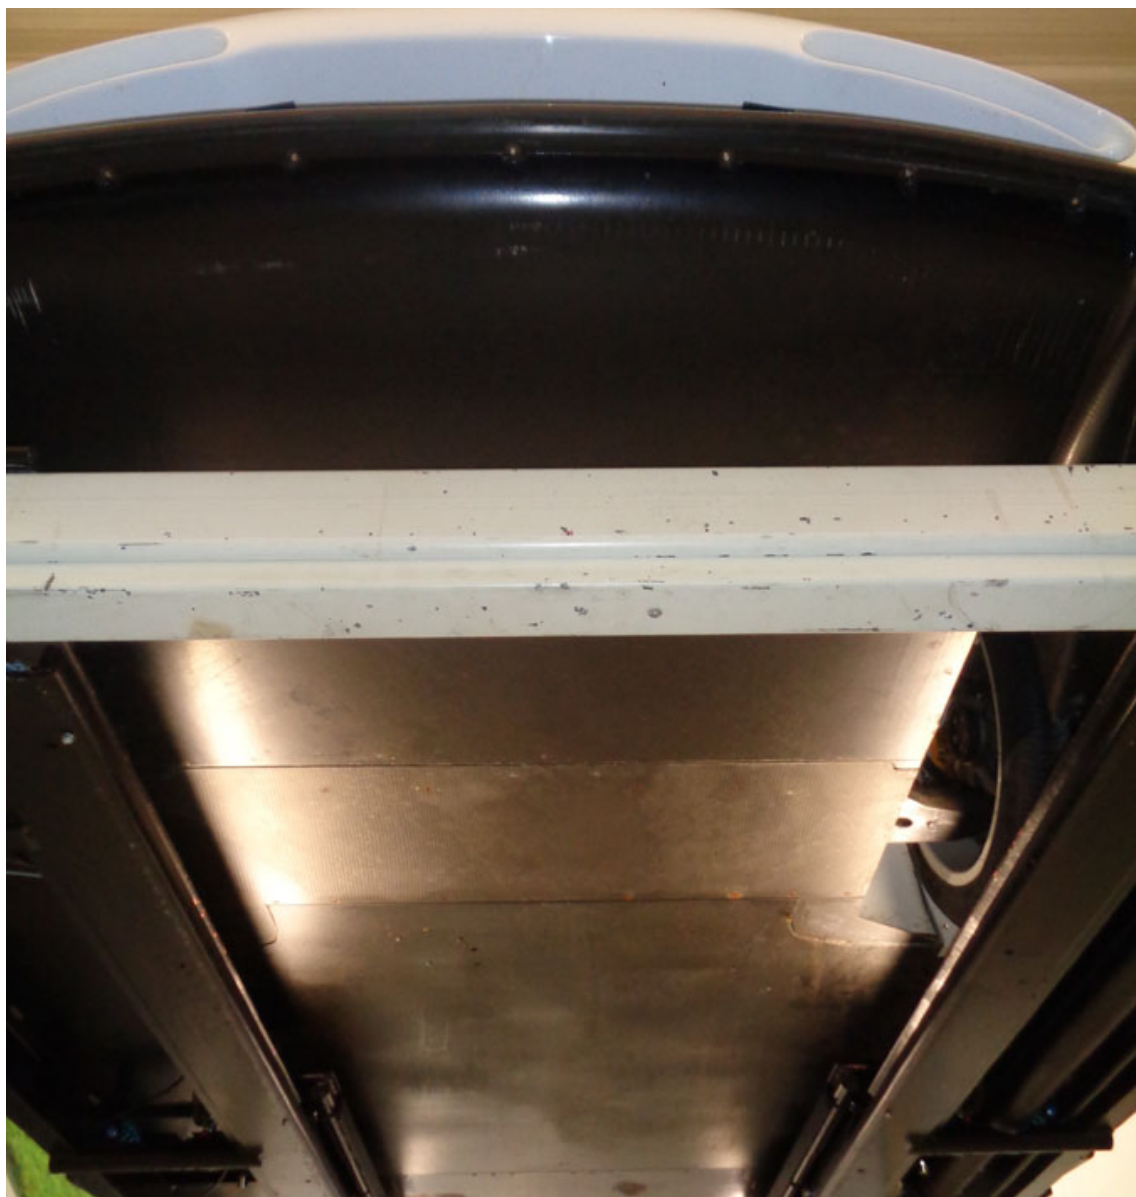
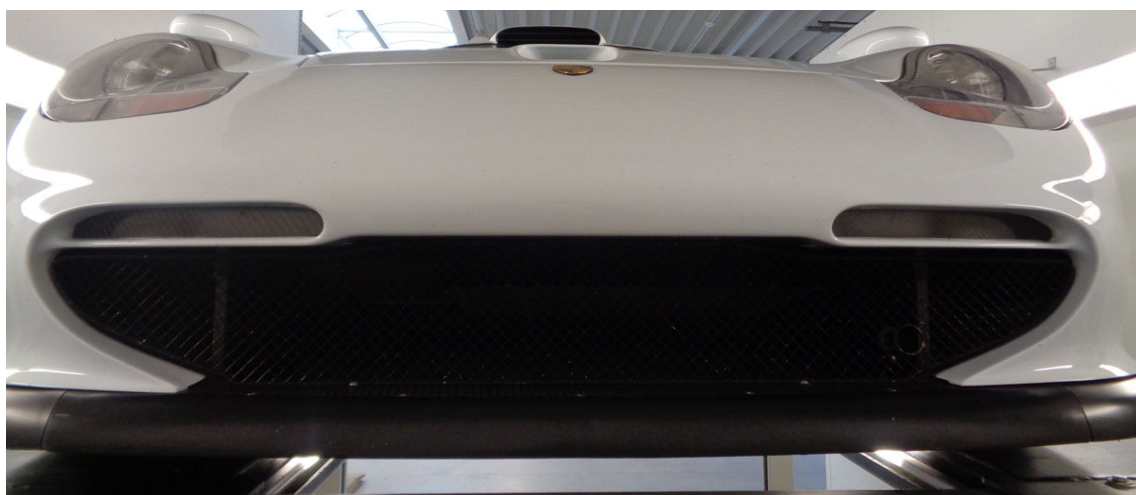
FLOOR PAN:

The flat carbon fibre floor panels have hardly any ground scraping damage on them, which is rare for a GT1.

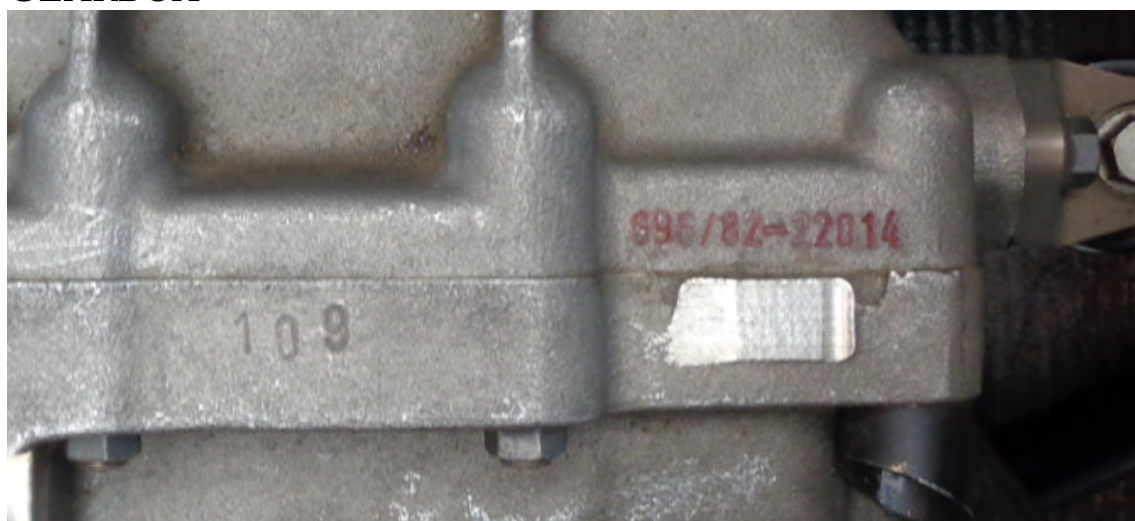
GEARBOX

Gearbox Number: G96/82-22014
